Electromagnetic Interference (EMI) *Inside* a Hard Disk Drive Due to *External* ESD

Douglas C. Smith (1), Al Wallash (2)

Abstract: GMR recording heads used in today's hard disk drives are very sensitive to damage from impulsive current transients caused by electrostatic discharge (ESD) and even the electromagnetic interference (EMI) due to a nearby ESD event.[1,2,3] In this work, we measure the EMI inside a hard disk drive due to a variety of ESD events outside the drive enclosure.

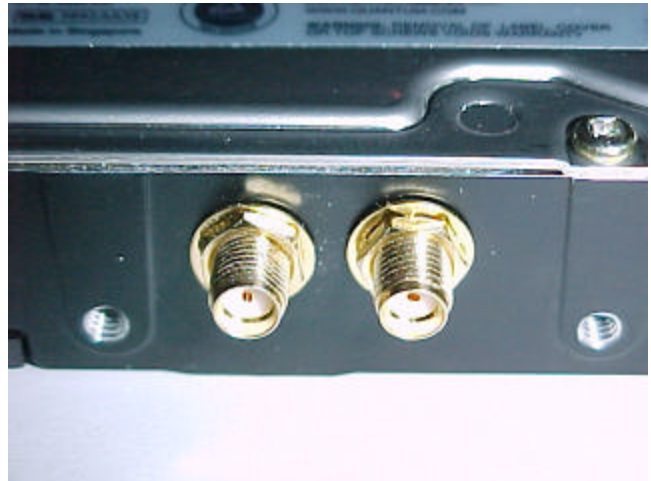
Figure 1: SMA Connectors Mounted on Drive Case

Figures 1 and 2 show how the drive was modified to measure EMI inside the drive. Two SMA connectors were mounted in the side of the drive enclosure and a small loop was placed inside the drive. The position of the loop near the flex cable to the head assembly is shown in Figure 3. Positioning the loop next to the flex cable allowed it to measure an Mdi/dt voltage drop estimate of the drop along the cable as well as internal fields.

The second SMA connector was used to make sure that the scope and connecting cable was not allowing ESD generated EMI to contaminate the measurement.

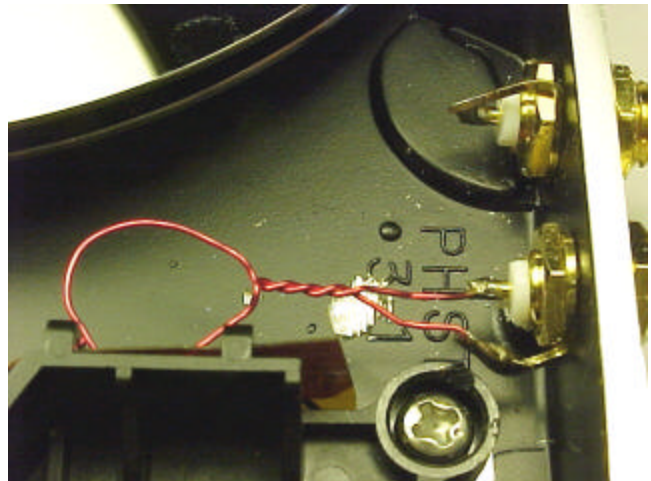
Figure 2: View of Loop Inside of Drive

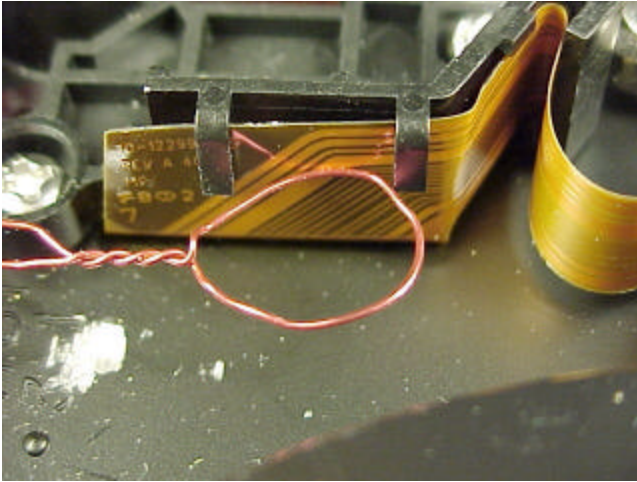
Figure 3: View of Loop Positioning Near Flex Cable

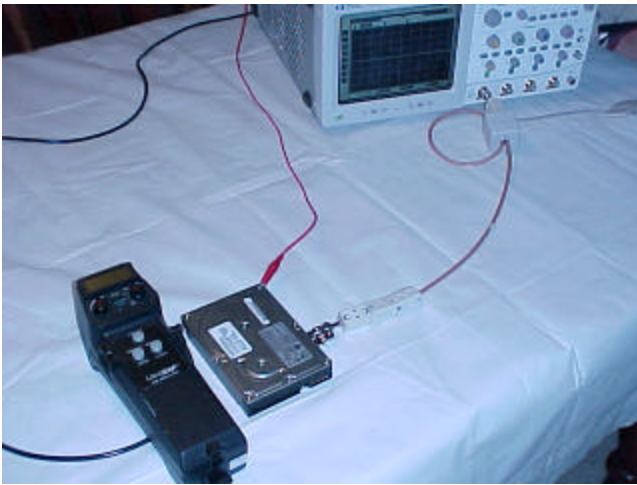
Figure 4 shows the general test setup. The drive was grounded to the scope chassis. This wire served to carry most of the ESD current to the back of the scope chassis. ESD currents flowing on the coaxial cable connected to the scope input were minimized by the presence of the grounding wire and the ferrite cores on both ends of the coaxial cable.

Figure 4: General ESD Test Setup

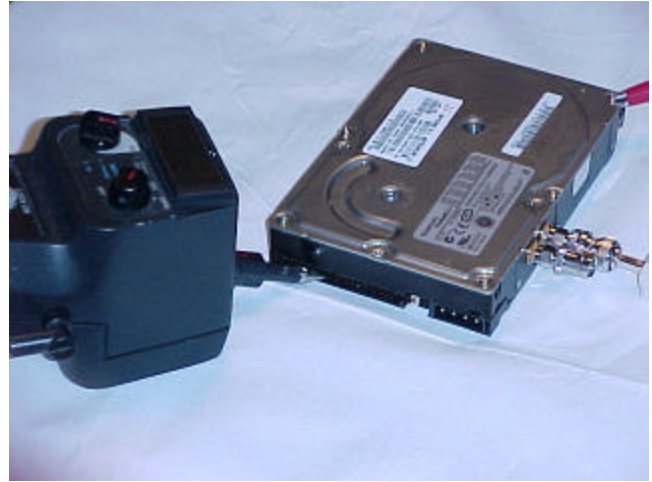
Figure 5: Applying ESD to Connector Pins

Application of ESD to the drive is shown in Figures 5, 6, and 7. Figure 5 shows the setup for application of ESD to the connector pins. Figure 6 shows direct application of ESD to the drive enclosure and Figure 7 shows radiated EMI from an ESD event. The EMI generator is made from two pieces of copper foil tape.[4]

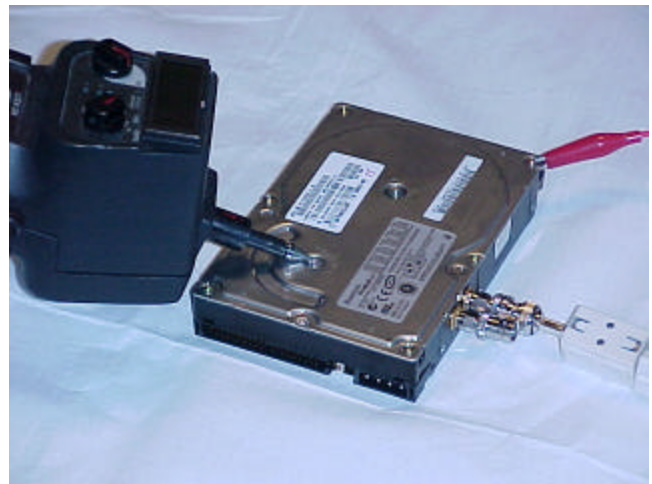
Figure 6: Applying ESD to Drive Enclosure

EMI is generated in Figure 6 by using a static charge to induce sparks between two pieces of copper foil separated by less than 1 mm. "Pops" in the nearby

AM radio confirm that sparks are taking place. The resulting EMI is very intense. A one meter flat IDE cable and a one meter lead connected pin #1 of the power connector were added to simulate connections to the drive.

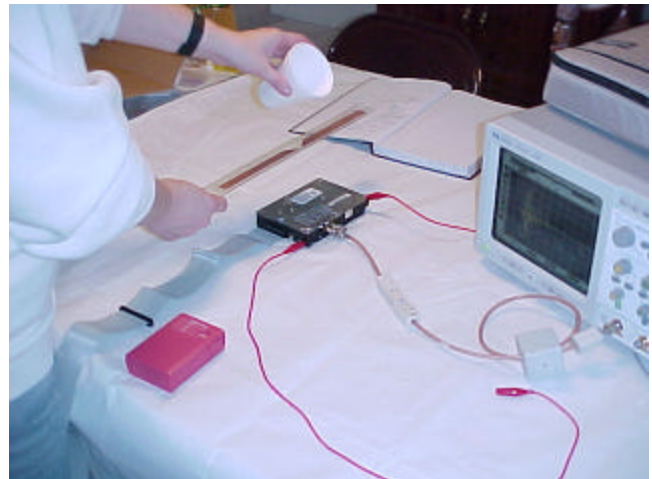
Figure 7: Indirect EMI Applied to Drive

Radiated tests were made with the test setup as shown in Figure 7 and with a KeyTek MiniZap ESD simulator. Contact discharges at 4 kV were done to the simulator ground lead about 1 meter from the drive assembly.

Figure 12 shows the sensing loop output when the copper foil gap spark generator was held as in Figure 7. Such an arrangement produces fairly severe radiated EMI at such close range and has induced a wide range of equipment problems in other settings. The peak voltage recorded was about 200 mV with the null experiment SMA output registering about 10 mV

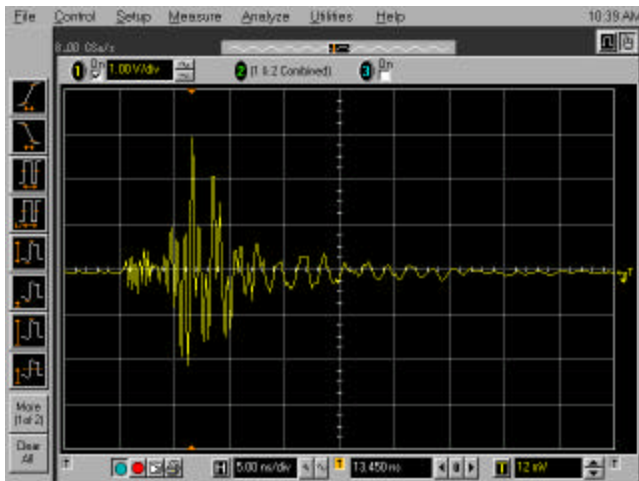
ESD applied to the connector pins yielded surprising results. Figure 8 shows the result of a 3 kV contact discharge to the corner pin of the power connector, pin 1. Almost 3 Volts peak was delivered by the loop installed in the drive to the 50Ω load at the scope! This represents 60 mA, enough to damage a head if the current were flowing in a GMR head. When the coaxial cable, high quality RG-142B/U, was moved to the "null" SMA connector, the scope registered only a 150 mV peak signal.

Figure 8: Loop Output from Discharge to Power Pin #1

This result raises the possibility that insertion of a power cable into a drive that has a charge on it, could potentially damage the GMR head.

The amplitude of the signal in the pickup loop was slightly smaller than when the ESD was applied to the two pins in the connector shown in Figures 8 and 9. The null experiment result was 150 mV.

An observation on the above waveforms: Some of the waveforms above (Figures 8, 9, 10, 11, and 13) have a small amount of EMI arriving at the scope before the main event by about 4 ns. Figure 12 does not show this and was the only waveform not using the ESD simulator. The amount of initial noise was also about the level of the null experiments. Note the time delay of the main event corresponds to the difference in propagation time between the simulator and scope in free space (~2 ns) versus the delay through the coax (~6 ns). This suggests that direct radiation from the intense contact discharge might be radiating a small

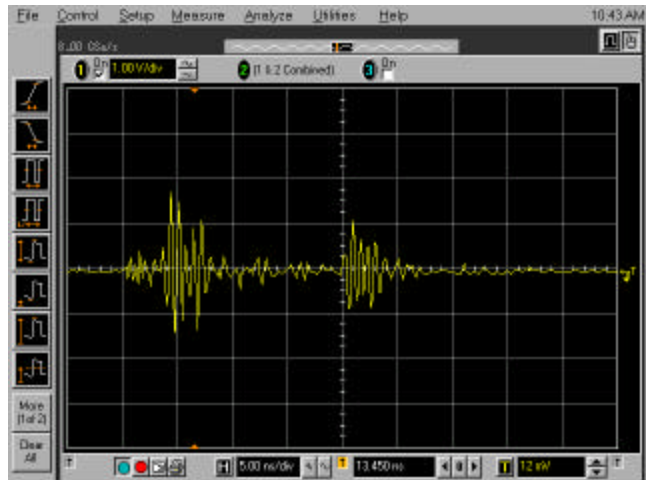
Figure 9 shows the loop pickup when the contact discharge was applied to one of the jumper pins. This is another point where ESD is likely to happen as a tool is used to insert or remove the jumper.

The peak value of about 1.5 Volts resulted in about 30 mA into the 50Ω load, a level that is potentially dangerous to a GMR head. Also notable is the double burst of signal. Possibly a secondary spark in the drive caused this, but that has not been confirmed.

Figure 9: Loop Output from Discharge to Power Pin #1

The null experiment (connecting the coax cable to the shorted SMA jack) yielded an output of 150 mV peak, within acceptable limits. This would have been lower if the jack were shorted with foil rather than a wire which formed a small loop with its resultant pickup.

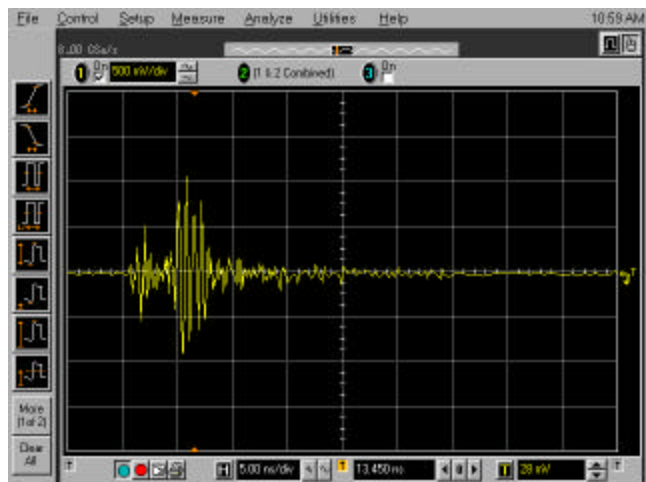
Figure 10 shows the loop pickup from a direct 3 kV contact discharge to the top of the disk enclosure at the screw on the mid-point of the side, near the SMA connectors. The result is similar to other locations on the top of the drive at about 1 Volt peak.

Figure 10: Loop Output from Discharge to Top of Drive Enclosure

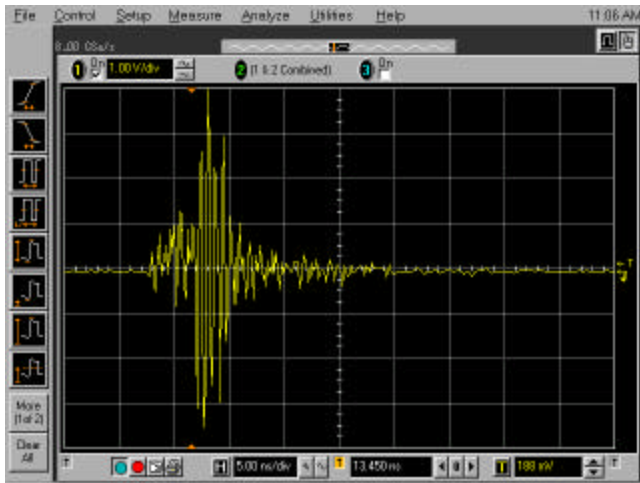
Figure 11 shows the result of the contact discharge at the edge of the top of the drive directly over the SMA connectors. The output is about 3.5 Volts peak with a

null experiment value of 1 Volt peak. The small loop formed on the null experiment connector contributed to the result of the null experiment as did other stray pickup. Note that the proximity of the discharge to the SMA connectors coupled with the fact that the drive gasket was non-conducting, allowed ESD currents into the drive between the cover and base.

Figure 11: Loop Output from Discharge to Edge Near the SMA Connectors.

Copper tape was placed along the edge of the drive on the same side as the SMA connectors to simulate the effect of a conductive gasket. The main loop output fell significantly from 3.5 Volts peak to about 1 Volt peak for the same discharge that resulted in Figure 11. This result suggests that a conductive gasket between the drive cover and body could provide significant shielding of the drive internal components from external ESD.

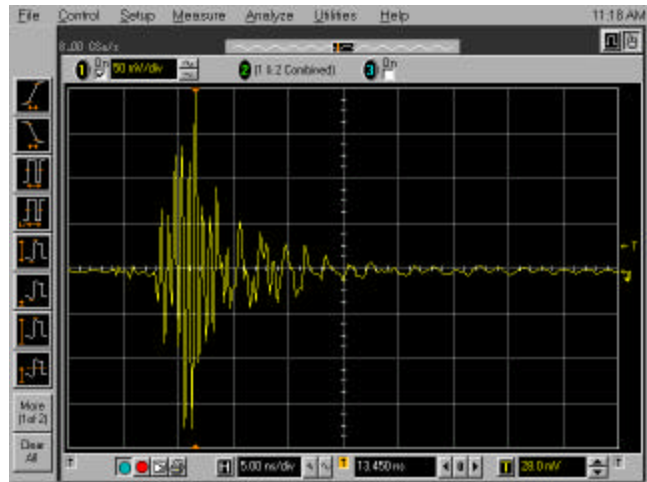
Figure 12: Loop Pickup from Copper Tape Spark Gap

A level of 200 mV represents about 5 mA into 50Ω. This is not as severe a problem as the direct discharges. As heads get more sensitive problems could arise though.

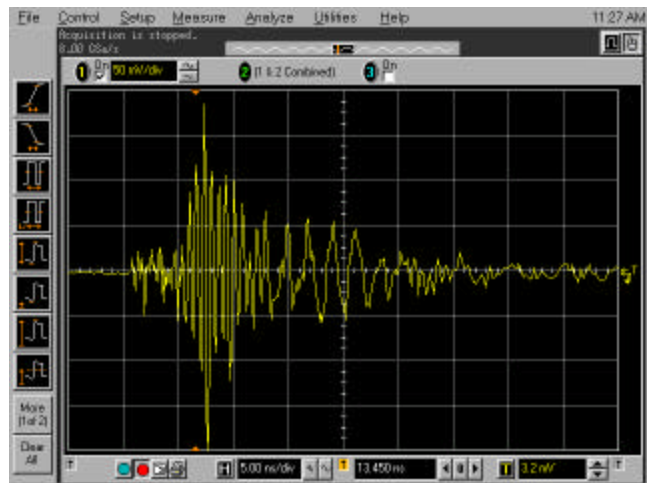
Figure 13 shows the result when the ESD simulator was contact discharged to its ground lead at a distance of about 1 meter. This is the arrangement that was able to melt a GMR head in open air from this

distance in a previous paper.[1] The result was about 200 mV peak as with the copper foil spark gap. The null experiment was about 30 mV for this experiment.

Figure 13: Loop Pickup from ESD Simulator Self-Discharge
