The EMI/ESD Environment of Large Server Installations

Douglas C. Smith

Mark Hogsett

Large installations of servers have become an important part of the infrastructure of our economy. Their reliability is of utmost concern. Results of an ongoing study of the EMI/ESD environment of server installations is reported herein and related to potential threats to equipment. The data to be presented shows a significant threat to the reliability of these installations.

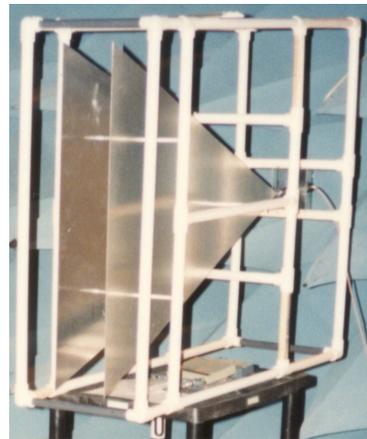
Figure 1 shows the antenna used for the measurements of specific maintenance operations. This type of antenna is called a TEM (transverse electromagnetic) antenna. Its structure is essentially a tapered transmission line with one end open. The electric field strength measured is simply given by:

antenna terminals. The vertical plates of the antenna shown in Figure 1 will respond to a horizontally polarized electric field.

Figure 1: TEM "Time Domain" Antenna

The advantage of this antenna is that it measures the true waveshape of the electric field of an electromagnetic wave. Most antennas have a resonant structure that has an oscillatory response to an impulse such as can be generated by an ESD event.

Measurements were taken using the facilities at Elliott Laboratories in Sunnyvale, California of specific maintenance operations using the TEM antenna of Figure 1. Measurements were made at a distance of 1.5 meters from the server, both in front of the server and to the side. The results were comparable for both the front and side, but slightly higher for the side readings. For all measurements, the person was charged to 500 Volts, a very low voltage that is far below the threshold of human perception of about 3500 Volts.

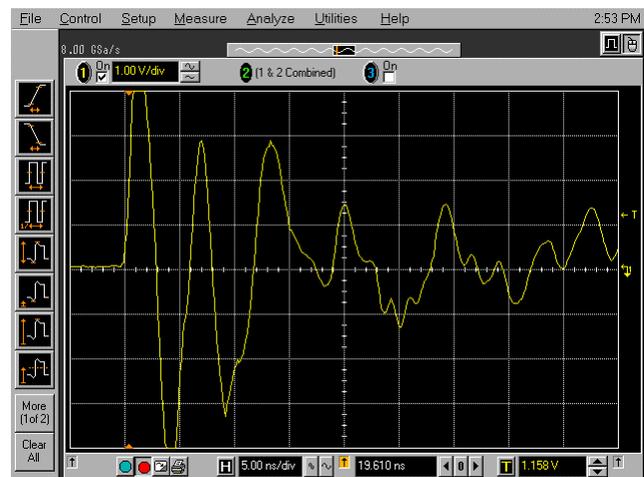
The peak value of the recorded waveform exceeded the ability of the scope (4 Volts full scale) to measure

it. An estimate of the peak based upon the observed waveform is about 8 Volts. This yields a field strength of ~ 55.2 Volts/meter! This is an intense field strength especially considering the measurement was made at 1.5 meters.

Figure 5: Field Strength Resulting From Disk Array Insertion

Insertion of a disk drive produced the similar result shown in Figure 4 and having an electric field intensity of ~ 19.3 Volts/meter. The higher ringing frequency of the disk drive insertion was likely due to its smaller size and the structure it was mounted in. This structure held several drives and itself was then inserted into the server with the resulting ESD generated fields shown in Figure 5.

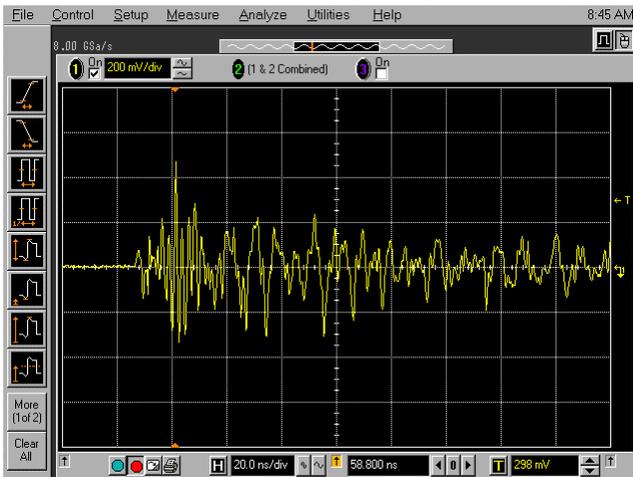
Figure 6 shows a typical measurement that was taken at a distance of 10 meters from a server that was being power cycled. The peak voltage of ~460 mV translates to a field strength of ~ 3.2 Volts/meter. That is a high strength to be measured at such a distance. Servers in the vicinity of this one would experience much higher fields comparable to the fields measured for specific maintenance operations above.

Figure 6: On-Site Field Measurement at 10 Meters

In Figure 6, the high frequency energy at the start of the plot, shown in Figure 7, is associated with the original impulse of the event being measured (possibly an electrical fast transient on the power line). The lower frequency oscillations later in the plot have more to do with resonance in the equipment and its connecting cables.
