An Unusual Source of Multiple ESD Events in Electronic Equipment

Copyright © 2015 Institute of Physics and Douglas C. Smith. Reprinted from the 2015 Institute of Physics Electrostatics Symposium in Southampton, England.

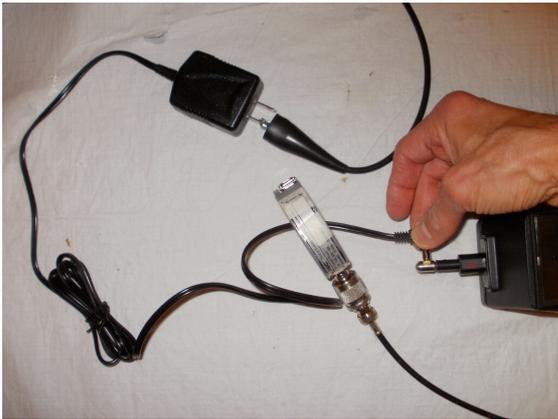
Figures 1 and 2 show details of the simplified test setup. In Figure 1, the AC mains connection of the supply was connected to the ground lead connection of the ESD simulator and the tip of the ESD simulator was connected to the low voltage connector from the supply. A Fischer Custom Communications F-65 current probe with a flat frequency response of 1 MHz to 1 GHz and a transfer impedance of one Ohm (one Volt/Amp) was used to measure the current.

Figure 1. Test setup.

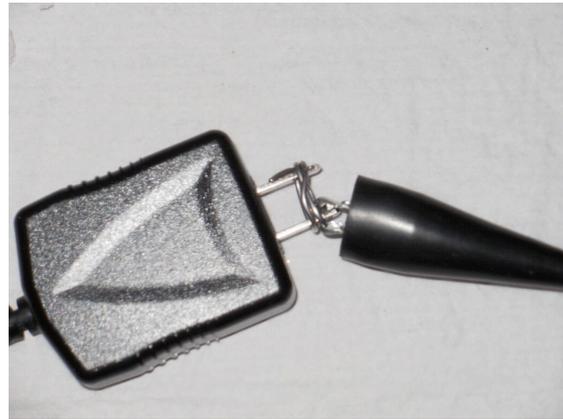
In Figure 2, the two AC mains connections are shorted together to rule out the possibility that a protection device across the mains (such as an MOV device) could be contributing to the effects reported here. Shorting the mains connections of the supply did not change the results.

Figure 2. Shorting of the mains connections.

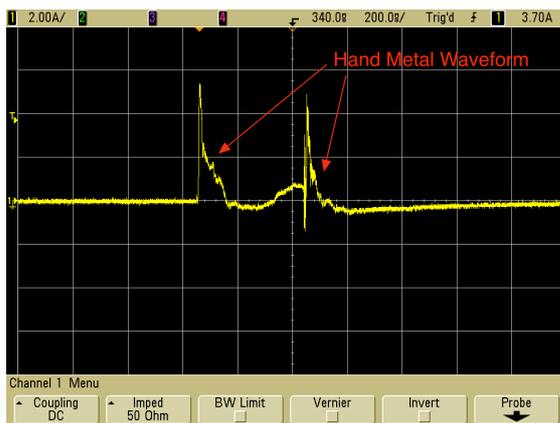
Figure 7 shows an initial applied current waveform *and* a secondary one having the appearance of a human metal waveform, similar to that described in IEC 61000-4-2.[1] However, a secondary event shown in Figure 8 has the appearance of a cable discharge event, having a flat region of current corresponding to the discharge of a common mode transmission line.[2] Note the duration of about 20 nanoseconds. This is the expected time delay around the loop of the low voltage power cord of the power supply and the ground lead of the ESD simulator.

Figure 7. Secondary event showing human metal waveform characteristics. Scale factors: 2 A/div and 200 ns/div.

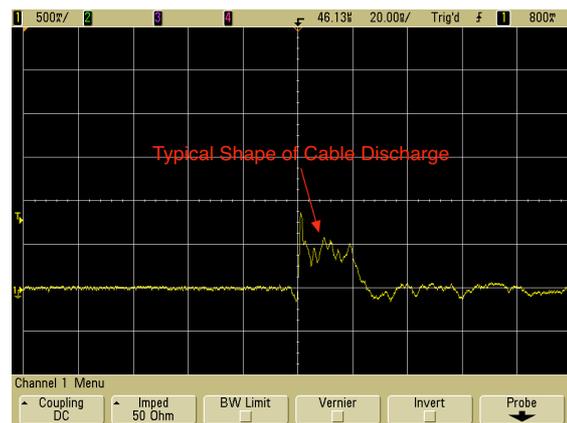
Figure 8. Secondary event showing cable discharge waveform characteristics with 20 ns width. Scale factors: 500 mA/div and 20 ns/div
